INCIDENT: OTCW Oil to Lake Michigan  
LOCATION: Whiting Refinery Lakefront, IN  
SUBJECT: Oiled Shoreline Assessment (SCAT) Report  
DATE: 30<sup>th</sup> March 2014

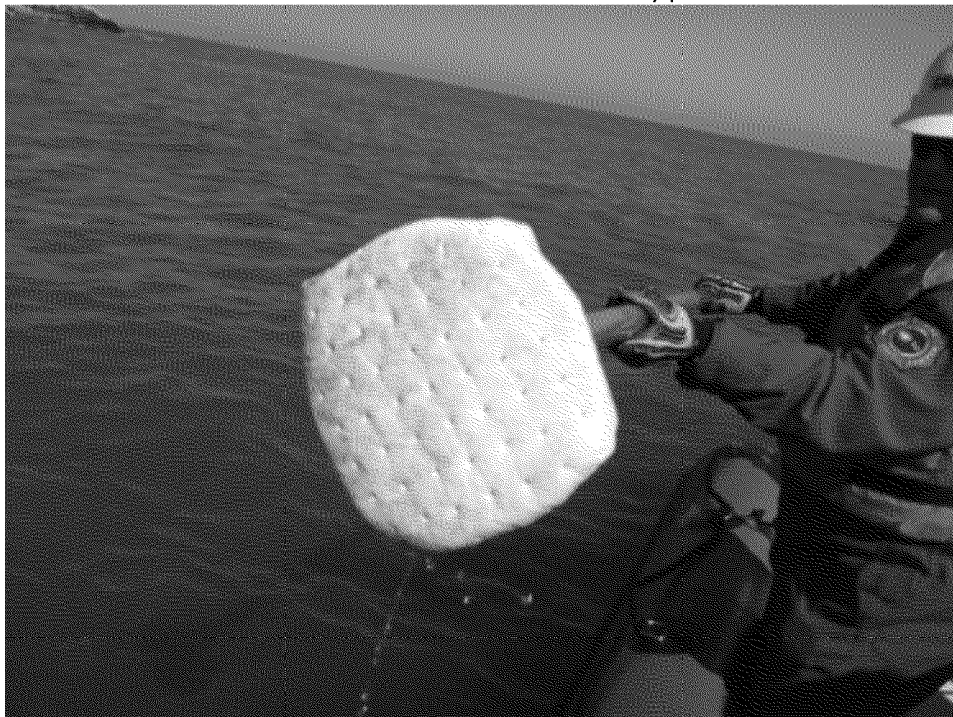
Clean absorbent at sunken oil survey point
